**SHEARER HILLS NEIGHBORHOOD HISTORIC SURVEY**  
SAN ANTONIO, TEXAS

This study is presented to the City of San Antonio, Office of Historic Preservation as a result of efforts on the part of UTSA College of Architecture graduate students in partial fulfillment of the requirements of the History and Theory of Preservation course of study.

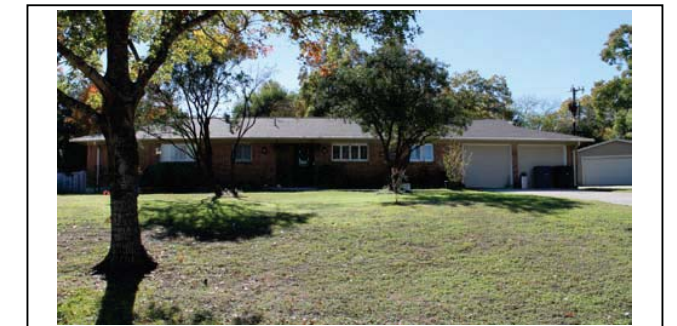
Principle Elevation

General Notes: Cracked driveway.

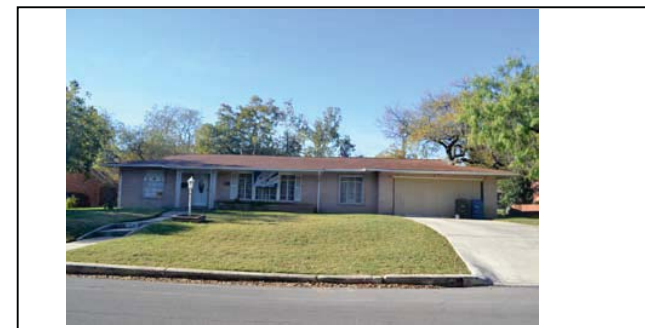
Principle Elevation

General Notes: Well maintained lawn. Wood shutters on windows.  
Lamp post has planter. Exterior wall cracking along front.

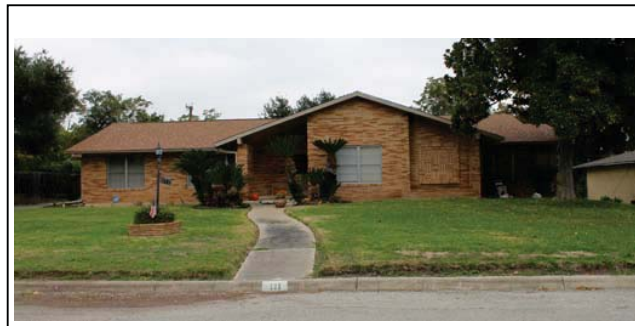
Principle Elevation

General Notes: Foundation Shifting on left side causing cracks in exterior wall.

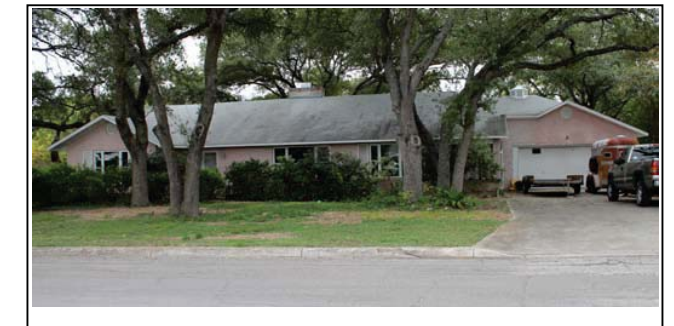
Principle Elevation

General Notes: Wall cracking over garage.
