**SHEARER HILLS NEIGHBORHOOD HISTORIC SURVEY**  
SAN ANTONIO, TEXAS

This study is presented to the City of San Antonio, Office of Historic Preservation as a result of efforts on the part of UTSA College of Architecture graduate students in partial fulfillment of the requirements of the History and Theory of Preservation course of study.

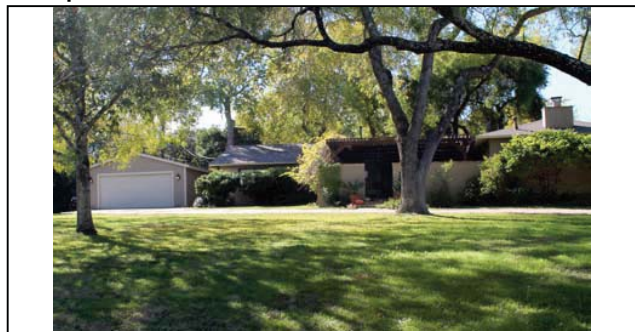
General Notes: Safe Route Flood light pole in front yard.

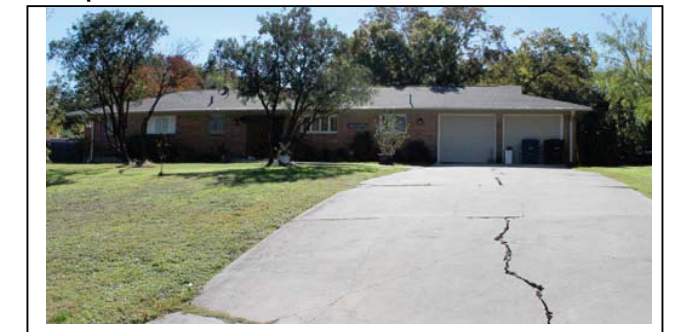
Oblique

General Notes: Cracked driveway.

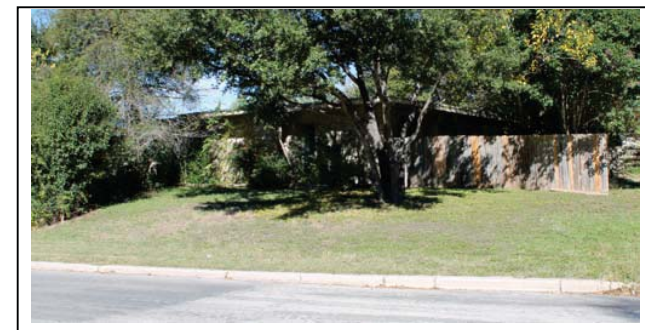
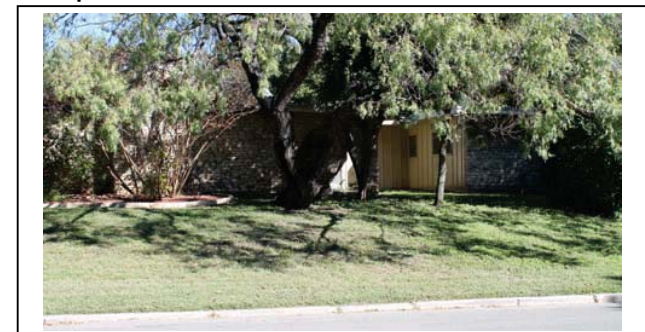
Additions/Alterations: Roof extension from garage to house.  
General Notes:  
Survey By: Adam Martinez and Barry Reyna Date: 12/3/2013

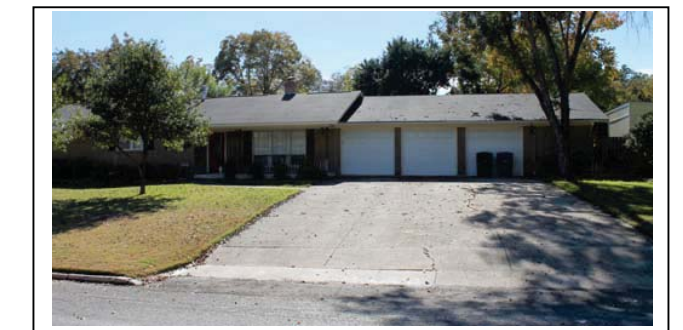
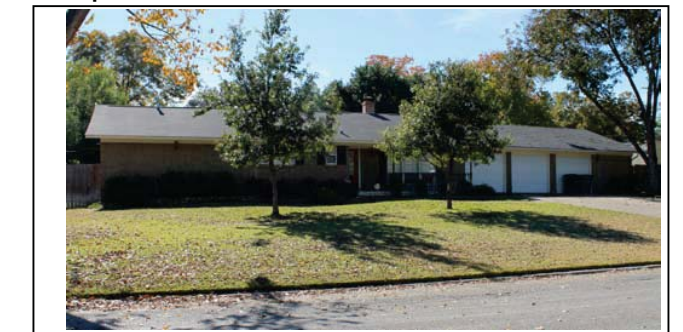
Additions/Alterations: Extended garage to three doors. Wood shutters.  
General Notes:  
Survey By: Barry Reyna and Adam Martinez Date: 12/3/2013

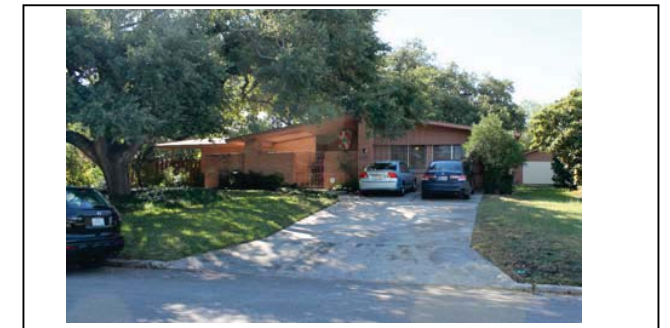
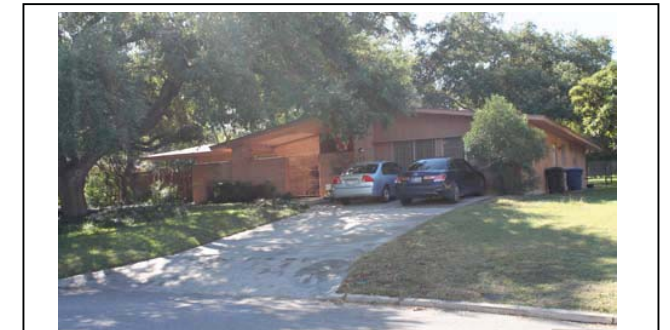
Additions/Alterations: Infilled Garage. Side Porch.  
General Notes: Courtyard in front. Ornamental bars on front gate and windows. Brick exterior wall.

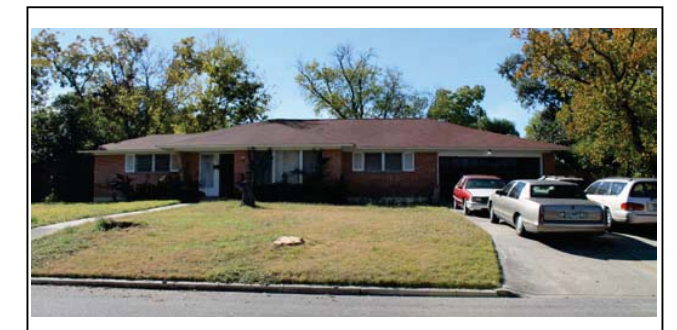
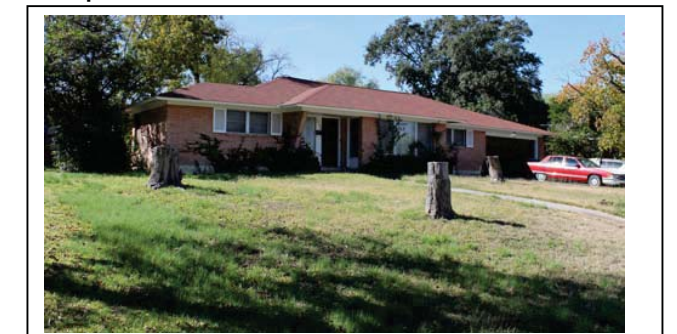
General Notes: Trees cut down in front.

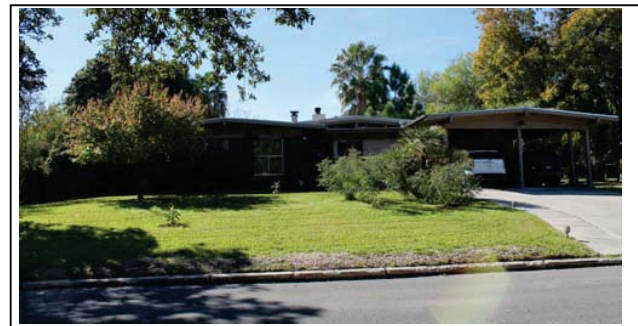
General Notes: Ivy on exterior walls. Fire hydrant in front yard.

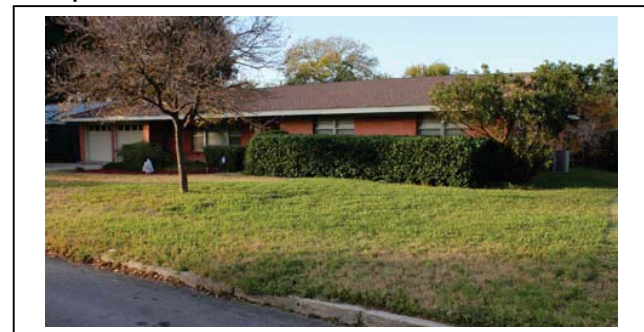
General Notes: Front yard fence is unstable. Driveway is alley and leads to garage in back. Long stairway in front for high slope. Stairway is brick and concrete.

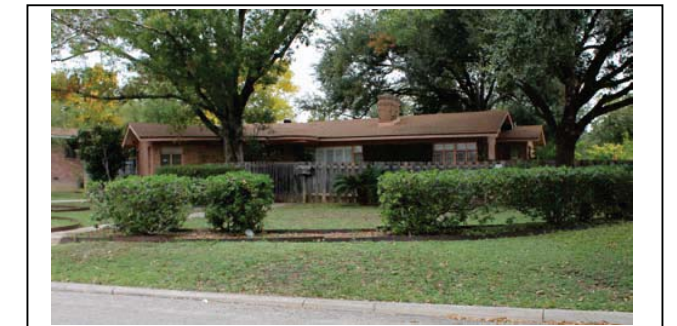
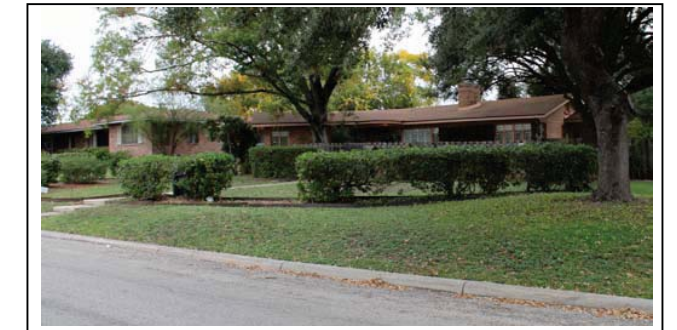
General Notes: Foundation Shifting on left side causing cracks in exterior wall.

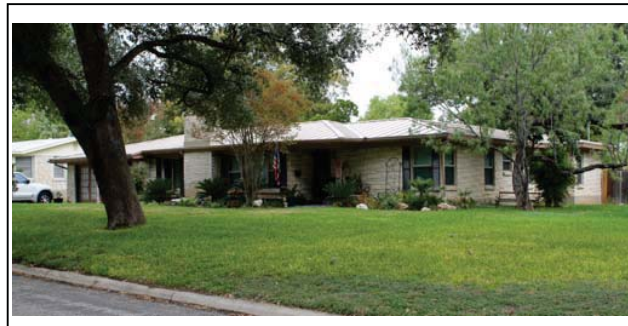
General Notes: Wall cracking over garage.
